1970-72 Cowl Induction Assembly

By Mark Meekins

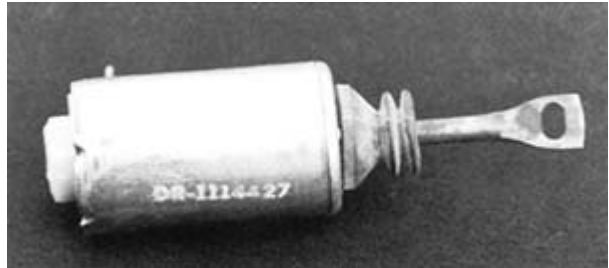
Original solenoid, part 1114427 is discontinued. However it has been reproduced. Our part number is [08-2160](#)

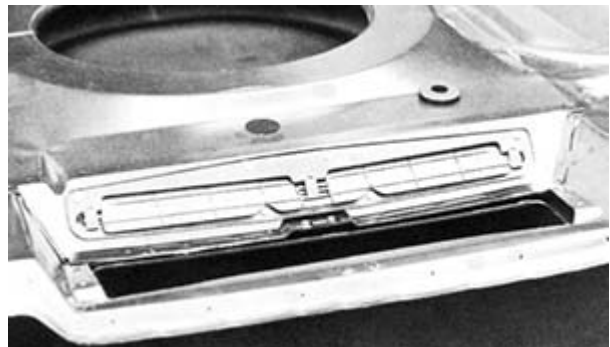
Six bolts with star washers are used to attach air valve assembly to hood.

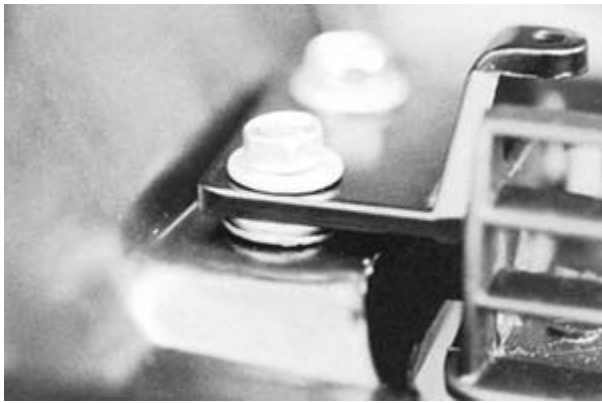
Original spacers are no longer available. Washers were used to shim flapper door where needed to level it with exterior hood surface.
