DRIVING OLD CARS

BUILDING AN OLD CAR LIBRARY-

“Research Before You Restore”

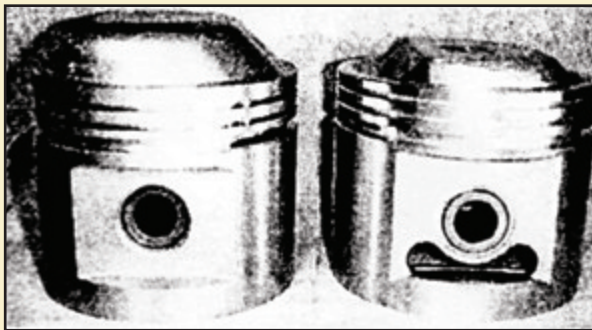
'53 & '54 BUICK PISTONS

the upgrades to make the car run at its best. When the first '53 Roadmasters and Supers rolled off the assembly line, they were fitted with high dome pistons.* The '53's first issue pistons measured 2.578” This measures from the center of the piston pin to the top of the piston dome, compared with a measurement of 2.180” on the '54 pistons—a difference of .398”! Our '53 had its original 322 V8 engine, but when we took it apart, it had low-dome '54 pistons and heads, and curiously, the block had never been bored, leaving us to believe it

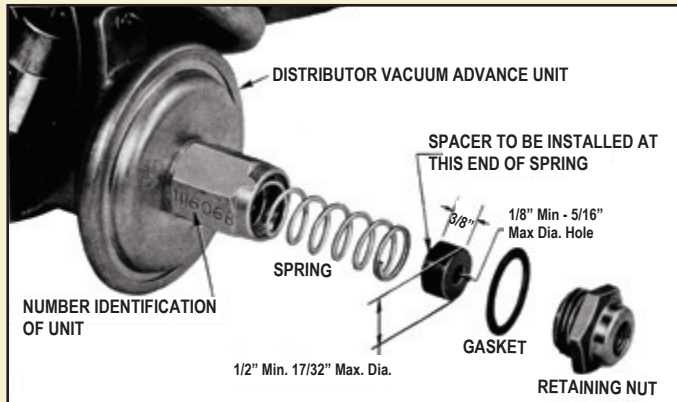
'53 BUICK R/M VACUUM ADVANCE

spark rap during acceleration." This was published in a well-read magazine of the time and could have led to the piston design change, but further reading in Buick's "Product Service Bulletin" manual, they reported mild to moderate spark rap with a pinging sound during acceleration, and listed the first issue vacuum advance as a possible cause. Buick's remedy was to issue a new vacuum advance with a 3/8" long spacer between the vacuum advance unit spring and the spring retaining nut on the distributor. This was done to lower the maximum spark advance. It also stated that the spacer was to be used in vacuum advance #1116068 and not to be used under any circumstances in vacuum advance #1116083. These kinds of details clearly matter on performance. I recently saw a GM Delco-Remy NOS vacuum advance on eBay listed for '53-'56 Buicks "all." Before I ordered it, I would want to know what the part number is and if it is a #1116083, to make sure the spacer had not been added. Another problem that could have been prevented on our '53 was not to run the engine without an ignition (ballast) resistor.** The previous owner said he had just tuned the car and had gone through the entire ignition system. When we were checking the car in, we were inside with the key on, when suddenly we saw smoke! A fire had started at the coil, which is of course, right next to the glass bowl AC fuel filter at the carburetor. Fortunately, we got the fire out before doing much damage, but not before melting some wiring, blowing up the coil and melting the distributor cap! After a stiff Diet Coke, we checked our wiring diagram and saw that the ignition resistor had been left out of the ignition system. We added one (they're only about \$10 for a NORS one) but the real cost was replacing everything else. A review of the wiring schematic when we brought the car in would have prevented the entire problem. I now have read all 180 pages in the "Product Service Bulletin" for '53 Buicks, and I can tell you, it is easier to read about the changes the factory made, than for me to work them out in the shop!

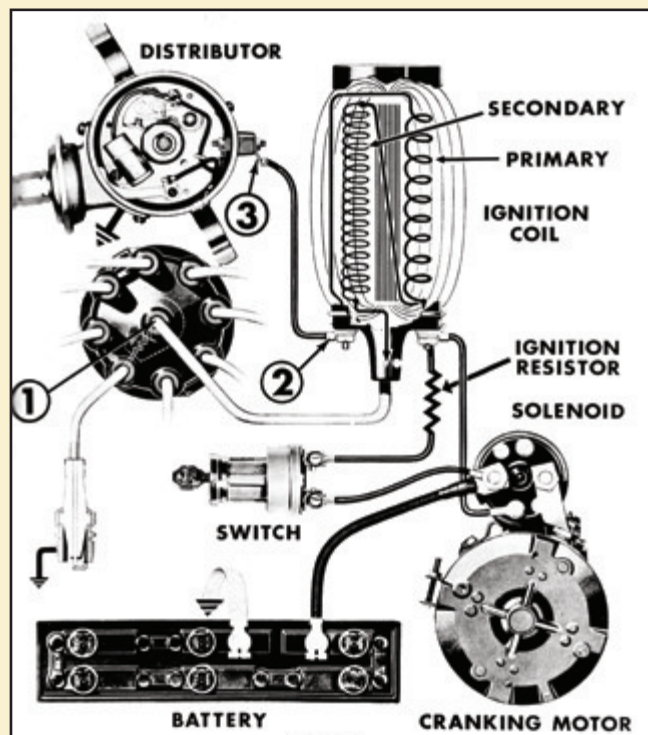
'53 BUICK R/M IGNITION SYSTEM

spark rap during acceleration." This was published in a well-read magazine of the time and could have led to the piston design change, but further reading in Buick's "Product Service Bulletin" manual, they reported mild to moderate spark rap with a pinging sound during acceleration, and listed the first issue vacuum advance as a possible cause. Buick's remedy was to issue a new vacuum advance with a 3/8" long spacer between the vacuum advance unit spring and the spring retaining nut on the distributor. This was done to lower the maximum spark advance. It also
